TECHNICAL BULLETIN TB-10

Diagram for fitting relay

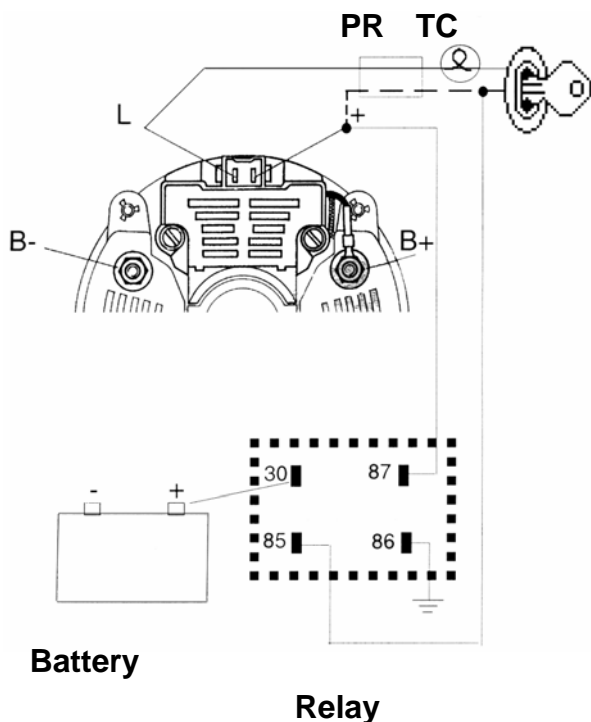
It is a common fault that the dashboard warning lamp glows dimly after starting the engine. This fault is often caused by low voltage at the '+' terminal on the regulator (i.e. less than 12 volts).

A loss of voltage can be caused by additional accessories installed on the vehicle, bad or corroded connections on the engine wiring circuit of the vehicle.

Or engine could have a poor or resistive earth strap connection.

This can be rectified by installing an additional relay (see diagram).
