TECHNICAL BULLETIN TB-41

Charging system Isuzu / Opel / Vauxhall

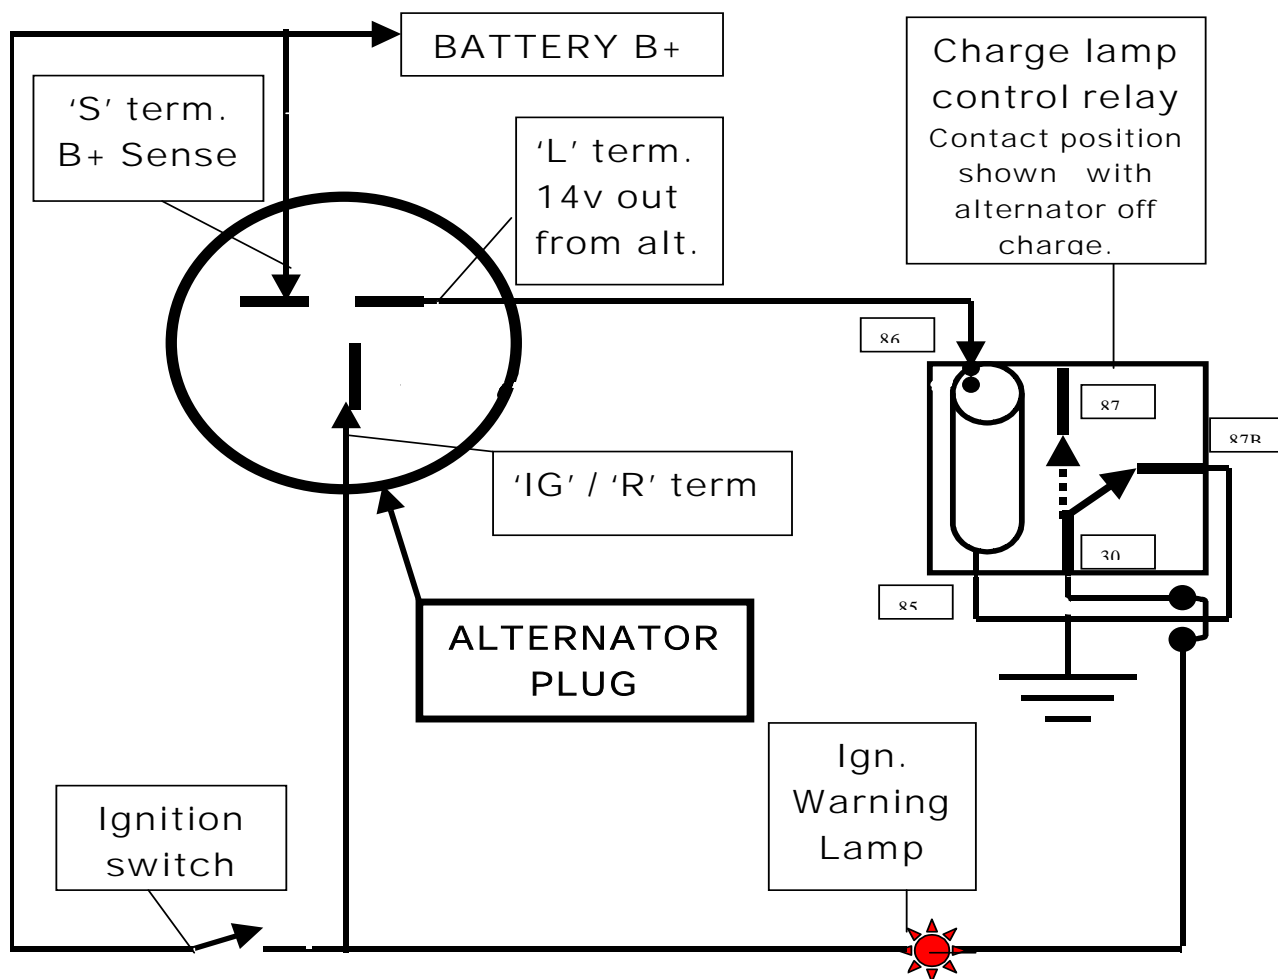
The charging system on most Isuzu, Opel and Vauxhall applications fitted with these alternators have a charge relay fitted in the circuit. One of the functions of this relay is to control the charging warning lamp. When the original alternator fails, it is possible for excessive voltage to be produced at the 'L' terminal, this high voltage can overheat/burnout the relay coil. The relay must be checked for serviceability before installing the replacement alternator. Failure to do so could prevent the replacement alternator from charging.

NOTE. The ignition supply is used to excite the alternator not the lamp circuit. Circuit above shows approximate correct operating voltages.
